TM 4967:70-616

DATE 24 February 1970

TECHNICAL MEMORANDUM

TITLE: Operation and Post-Test Inspection of the SNAP-8
Pre-Prototype Boiler P/N CF 751840, S/N 2

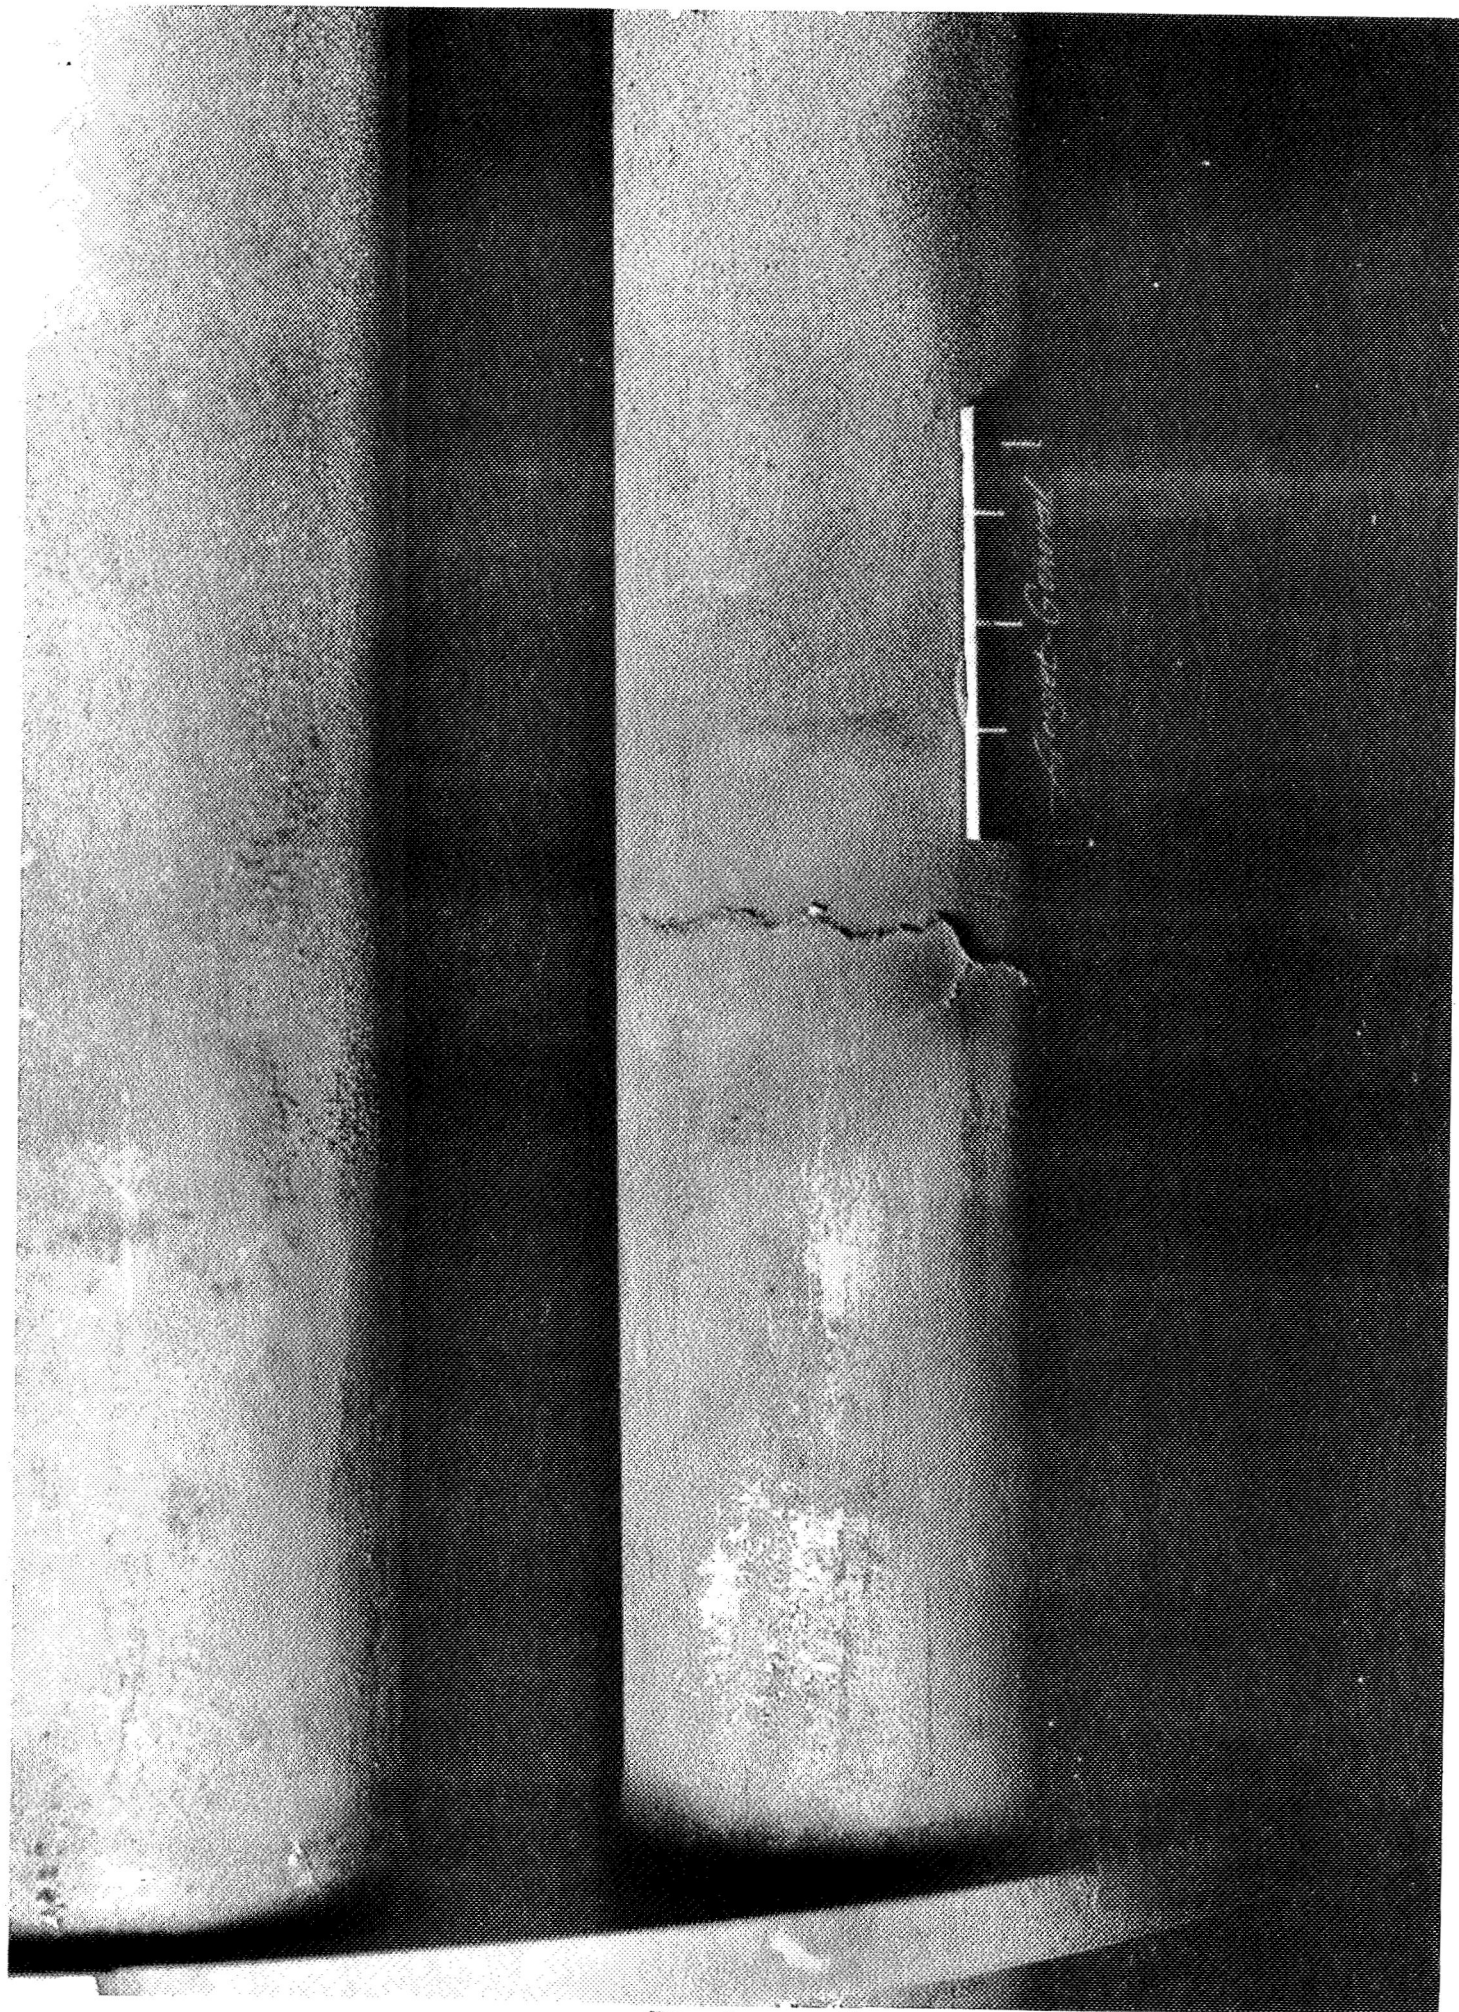
FIG 19

Figure 19 - The crack is shown looking at the boiler static NaK tube 90° from that shown in Figure 17. The circumferential crack had propagated approximately 3/4 of the way around the tube and was in the area where the tube commenced to go from circular (to the left) to elliptical. The adjacent surfaces of this crack appeared to be washed out in a similar manner to that noted on the tantalum tube underneath. The other 6 static NaK tubes showed no cracks or distress when examined with dye-check.

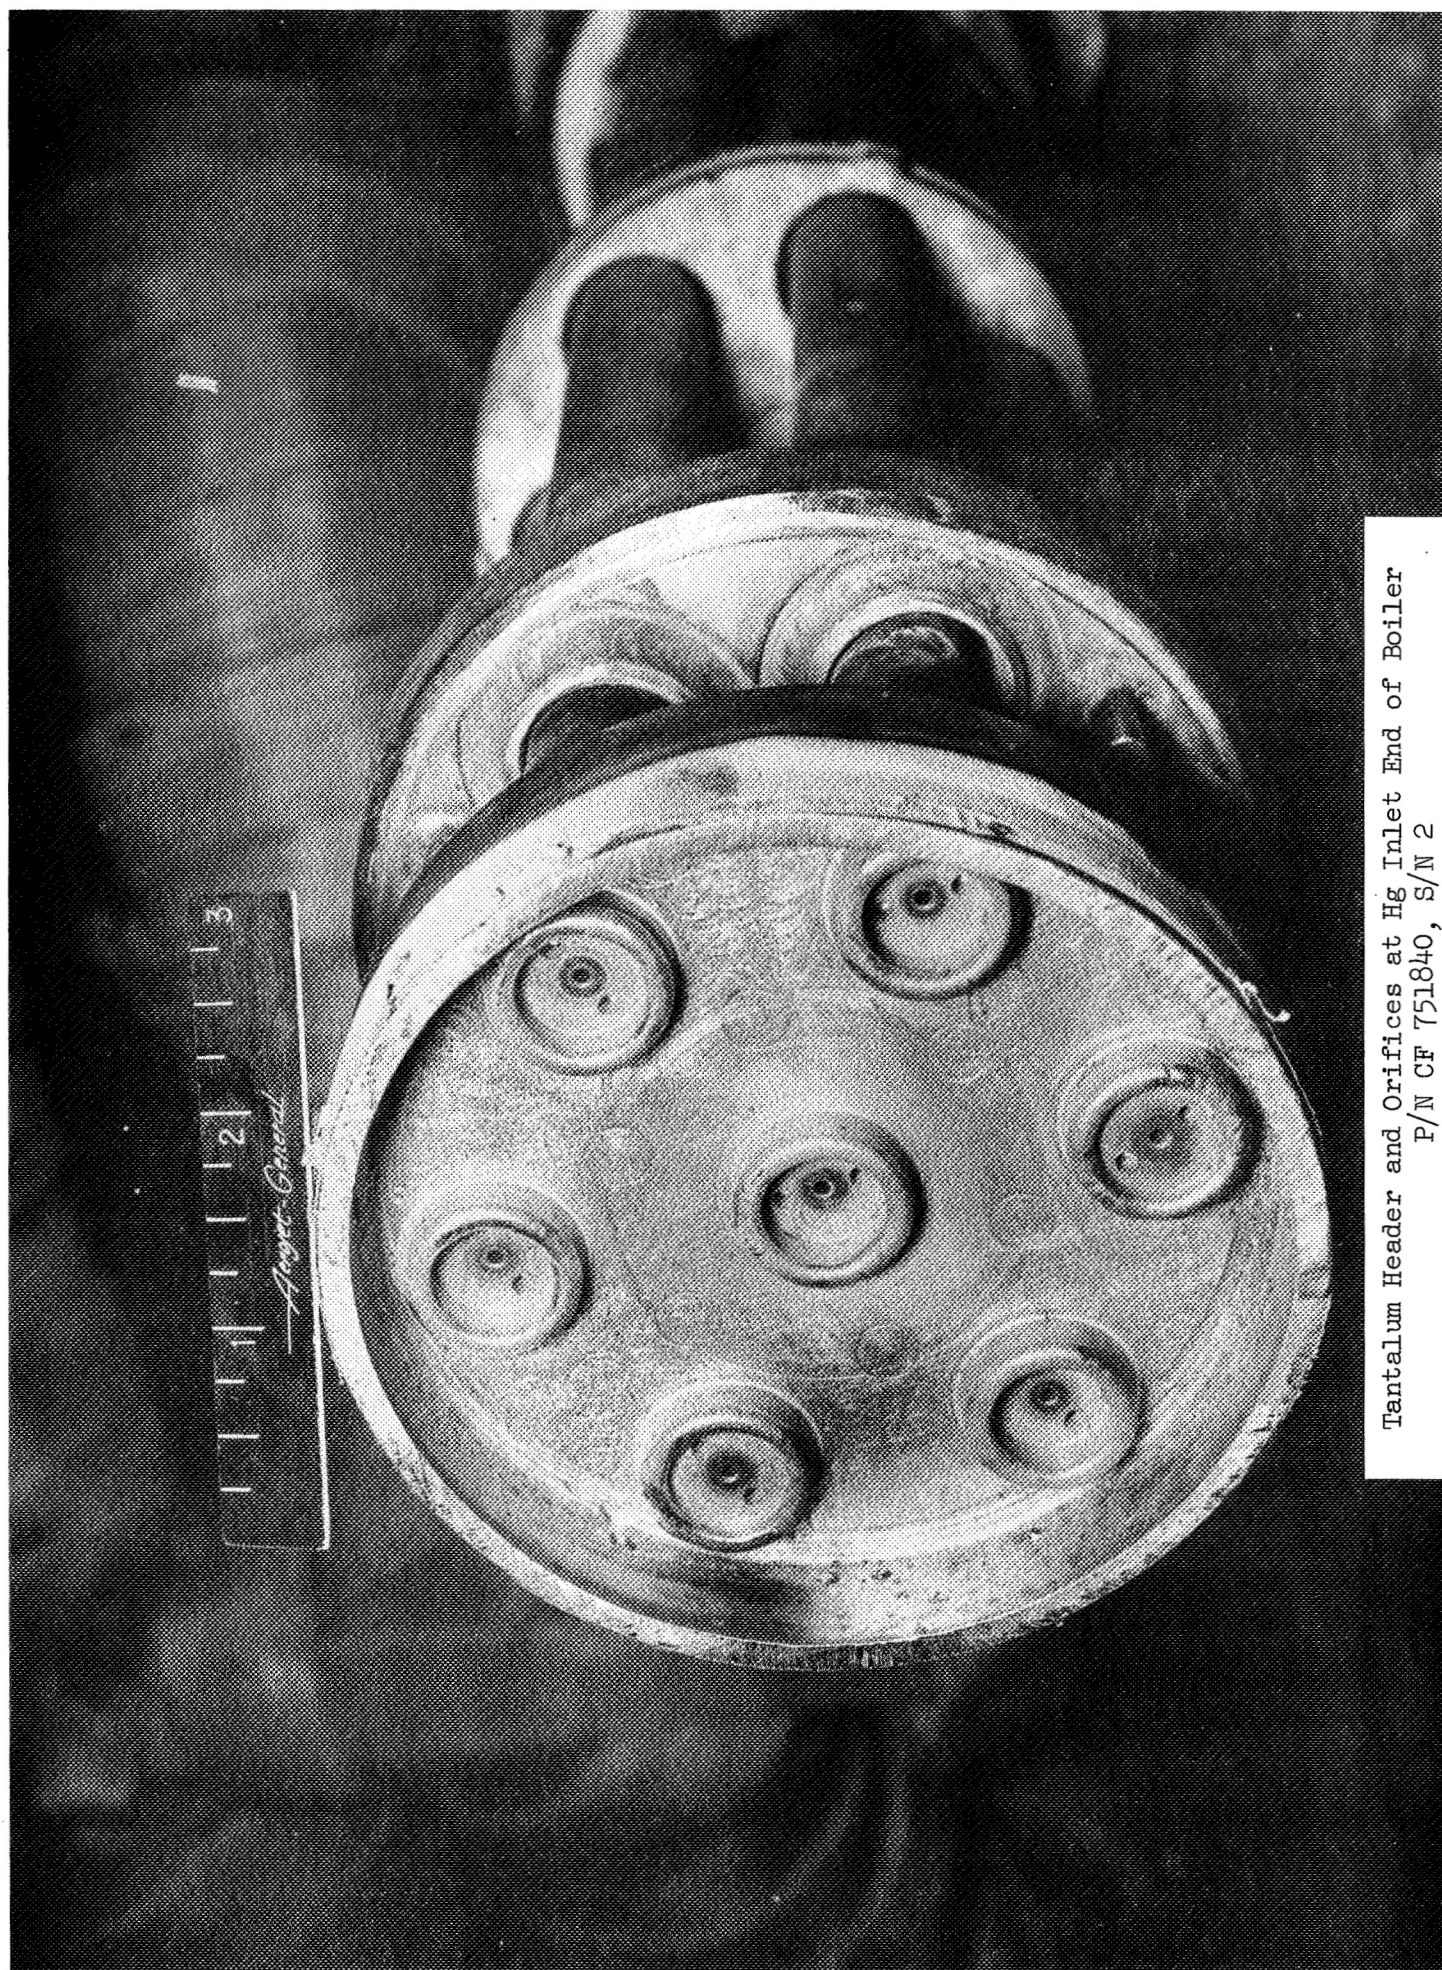
The mercury inlet tantalum dome was cut on a circumference just upstream of the dome-to-header weld. Visual inspection revealed no contamination in the dome, the header or the orifices. It was noted that the protrusion of each orifice varied, one to the other relative to the header plate. This was done during fabrication. The orifice-to-tube-to-header welds indicated that large grains precipitated during the welding. However, no discernible cracks were in evidence. Figure 22 shows a view of the Ta header after removal of the Ta dome.

Tantalum Header and Orifices at Hg Inlet End of Boiler
P/N CF 751840, S/N 2

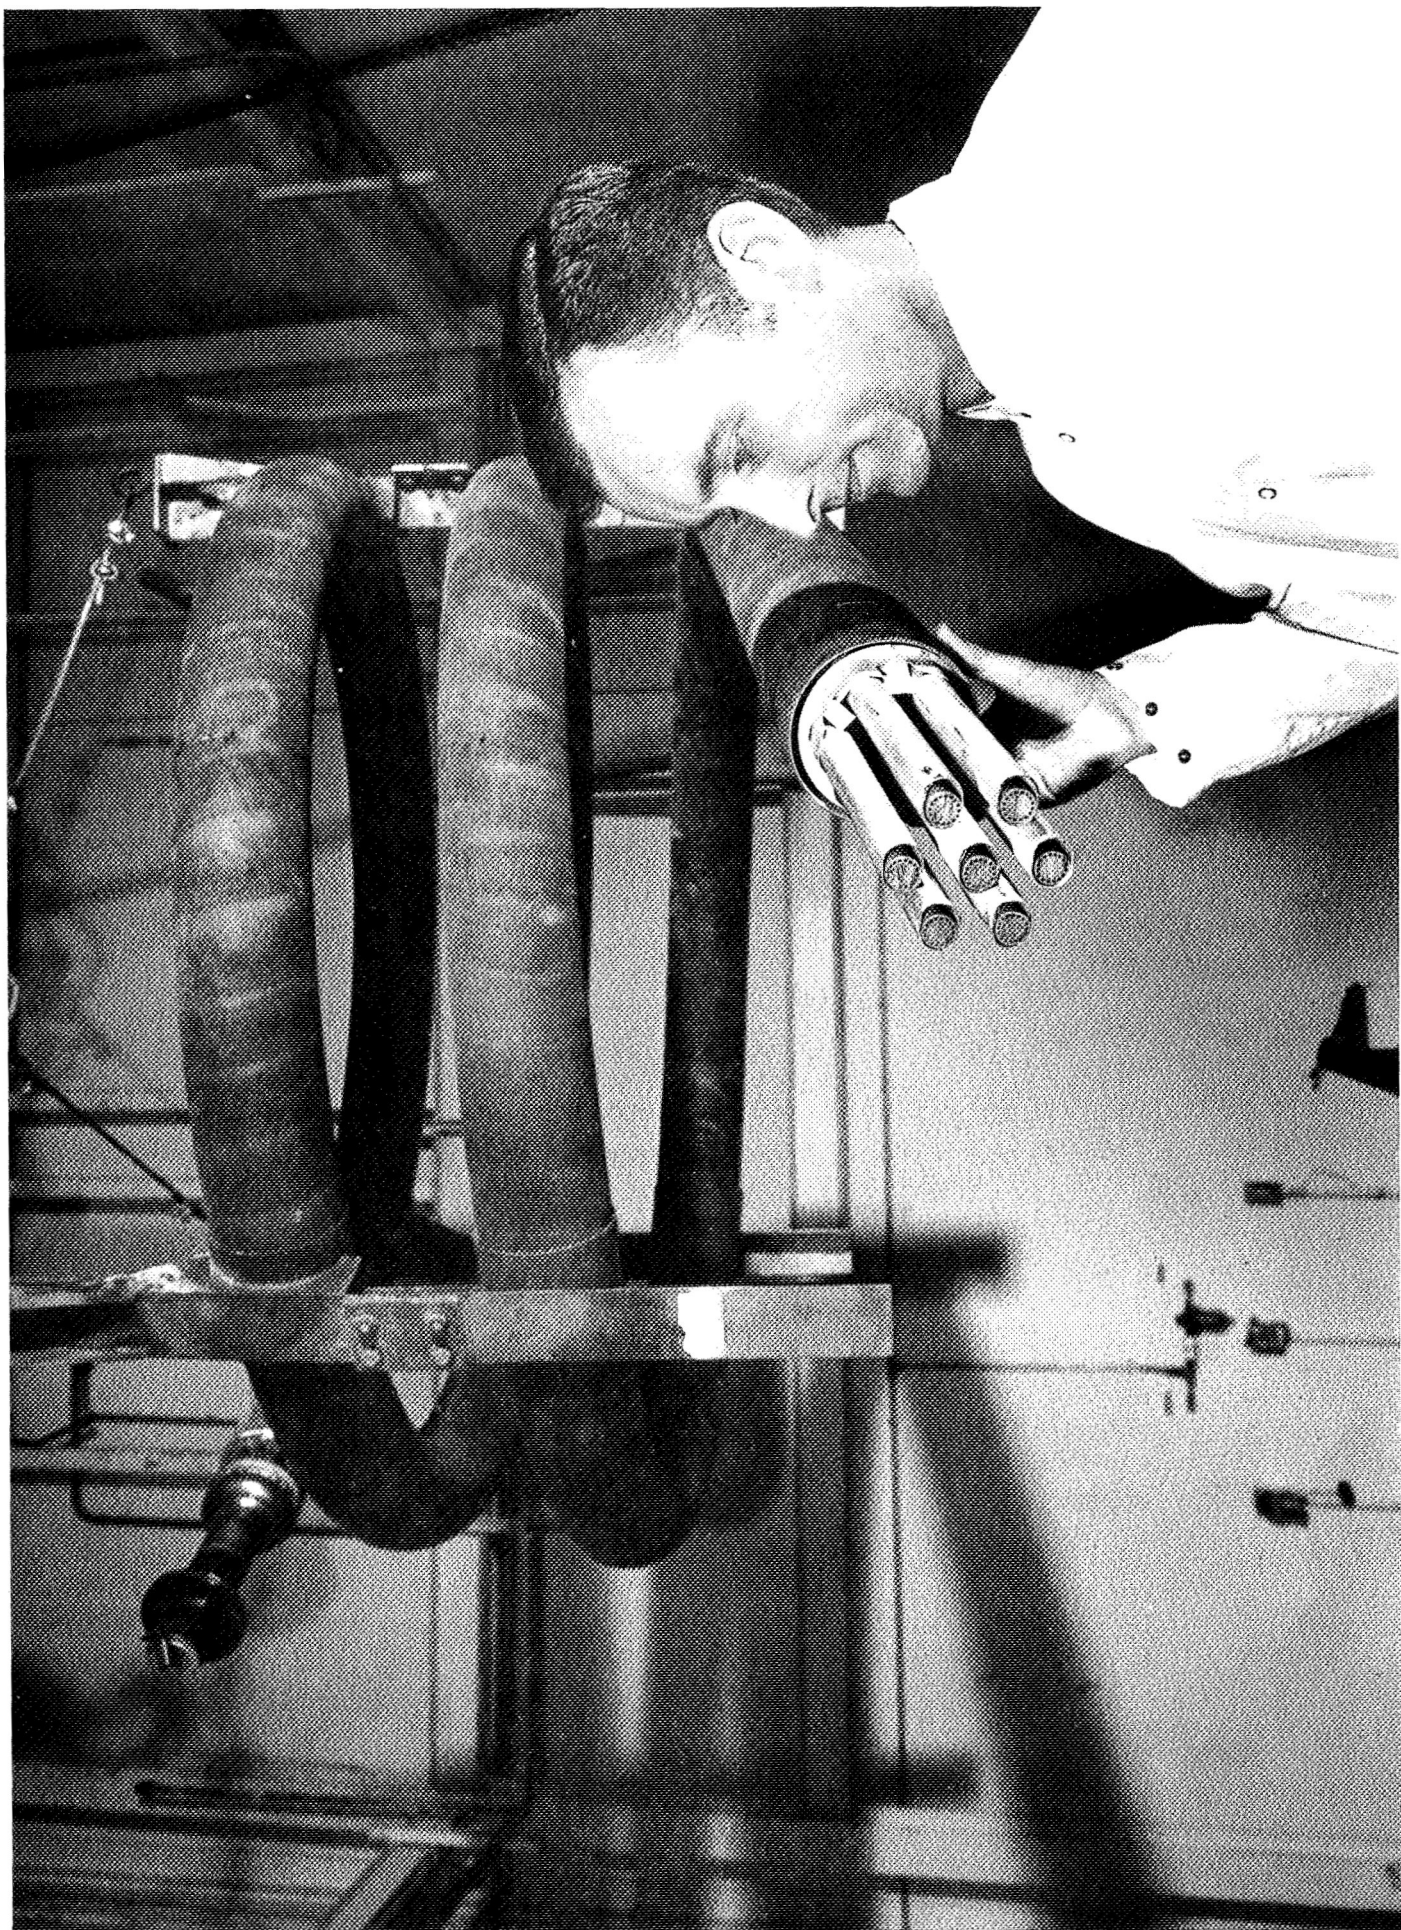
Removal of the Tantalum and Type 316SS headers from the Hg inlet was the last step in the boiler disassembly procedure. To separate the headers, the tube bundle was cut at a point such that the remaining plug insert length left in the boiler would be four feet. A front view of the 316SS header is shown in Figure 23. All of the tube-to-header welds were inspected and found to be free of defects. The three pins spaced 120° apart had been installed to prevent the two headers from contacting each other and to prevent over-extension of the tandem bellows. Figure 24 is a photograph of the boiler in its present state.

State of Boiler P/N CF 751840 S/N 2 After Disassembly

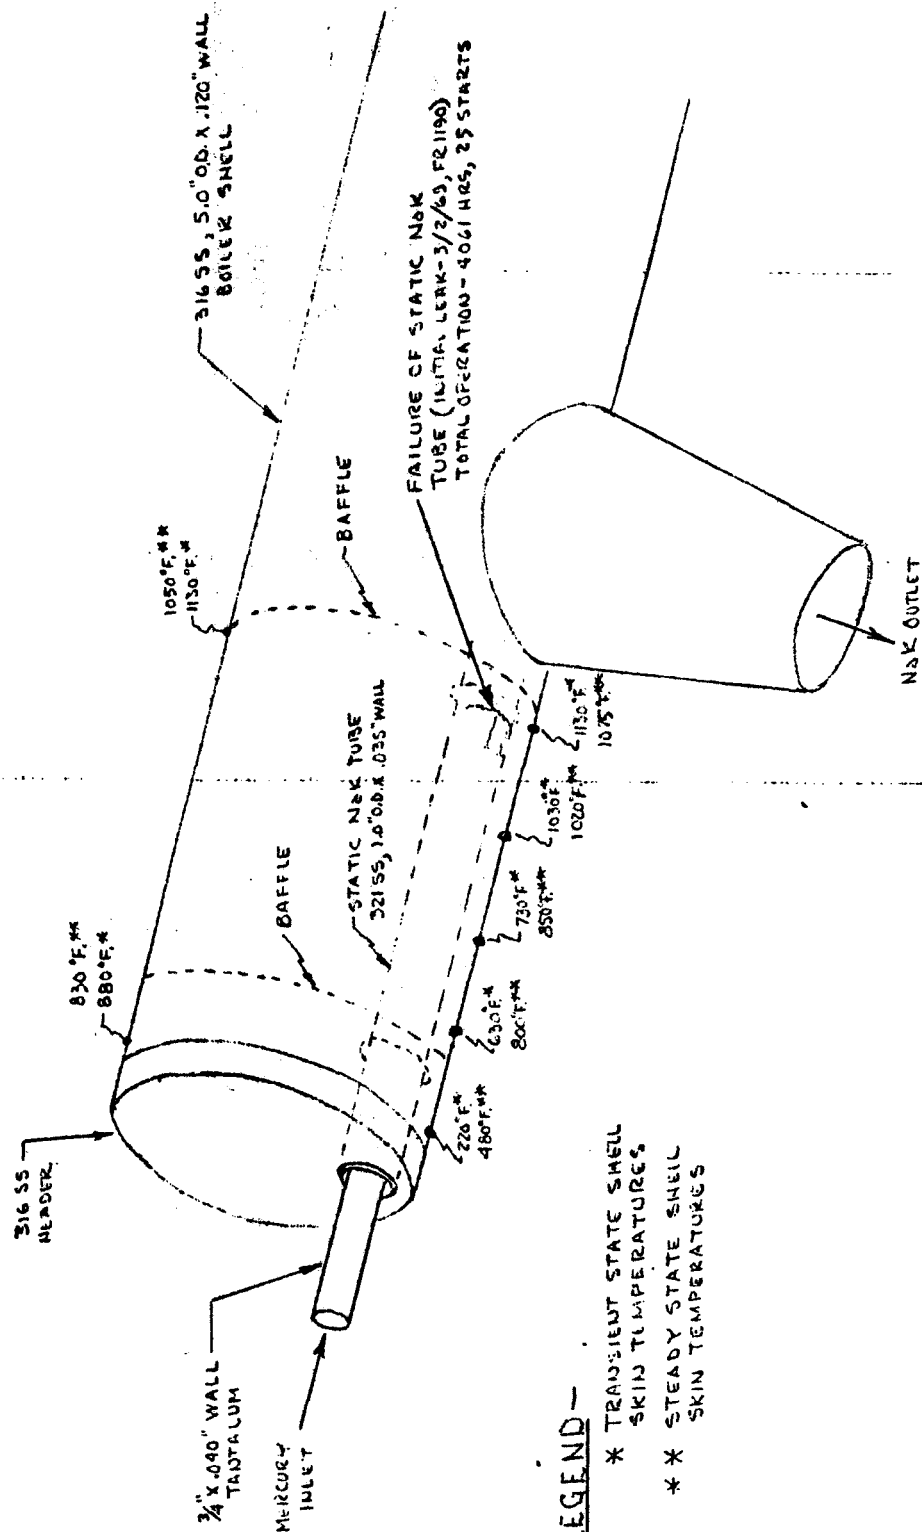
Figure 25

The failure of the 321SS tube occurred at the baffle nearest to the PNL exit port in the transition from round to oval cross-section as shown in Figure 25. Also shown in the figure are the temperatures for transient and steady-state conditions measured during test in PCS-1. The particular temperature profiles shown were chosen as being representative of the many profiles obtained since August 1968. Using these temperature data, Reference 5 states that for transient conditions, the stress was 44,000 psi and cyclic thermal stressing during startup/shutdown cycles was the predominant failure mode (See Appendix B).

3. It appears that the method of baffling the primary NaK flow at its exit has to be carefully analyzed to preclude excessive axial and circumferential thermal gradients versus axial and circumferential lengths. The cracks in the static NaK tube at the baffle indicate that thermal stress was the predominant failure mode.

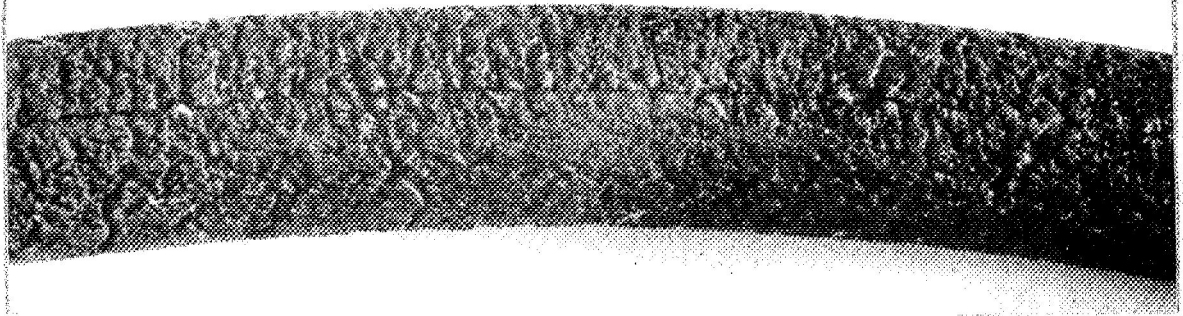
Shown in Appendix A is a two-inch long section of swirl wire that was found in the turbine Hg inlet filter (magnified 20 times) revealing numerous cracks. Metallographic examination of this piece of wire plus two other samples of wire not used in the boiler revealed that bending of the wire alone did not cause cracking and eventual fracture. Treatment of the two sample wires by chemical cleaning per specification AGC 10319/8 resulted in embrittlement as indicated by subsequent bending tests. However, it was found that after exposure at elevated temperatures, hydrogen was outgassed and ductility was restored. On three occasions during boiler operation (including that following the boiler chemical cleaning after 1313 hours) hydrogen was detected in the Hg loop. One source of hydrogen was various oils, that had been detected in the Hg loop.

The failure of the swirl wire was most probably due to the combination of the loss of ductility from hydrogen embrittlement and residual stresses in the wire from the coiling operation.

Figure 1 - Ta-10W wire removed from turbine Hg inlet filter.

2. The tantalum -10% tungsten swirl wire should be replaced with a material that is insensitive to hydrogen embrittlement. Although it was found that the cleaning process contributed to the hydrogen embrittlement, it is well known that hydrogen generation can emanate from the reactor and oil contaminants in the mercury loop.

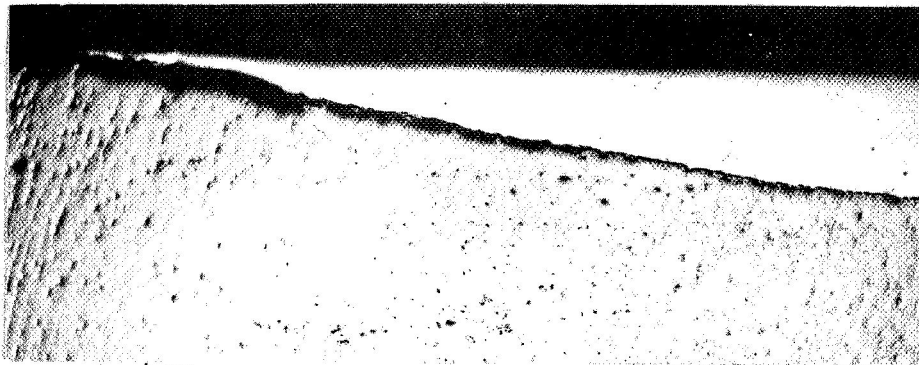
Appendix A shows a longitudinal section through the maximum debonded area of the Hg inlet transition joint. Reference 6 showed that this type of joint, made with the identical extrusion parameters, would continue to debond to failure in approximately 35 thermal cycles. The transition joint from the boiler had undergone 27 thermal cycles. Debonding had taken place on both the O.D. and I.D. of the joint for lateral distances of 0.323 inches and .012 inches, respectively.

5. The debonding of the hot co-extruded Ta/316SS transition joint at the Hg inlet was typical of the failure mode previously established for this type of joint by laboratory testing.

Figure 2 - Cross section through Ta/316SS transition joint from boiler Hg inlet showing debonding on O.D.

1. The tandem transition joint at the mercury inlet would have to be redesigned or the co-extrusion process would have to be more closely controlled to ensure a better tantalum-to-stainless steel bond. The short life of this type of joint was borne out by thermal cycling in the Metallurgical Laboratory. If increased life is unattainable, the joint should be replaced by an axially co-extruded bimetal joint of sufficient length or by a rigorously controlled brazed joint similar to the mercury outlet joint.

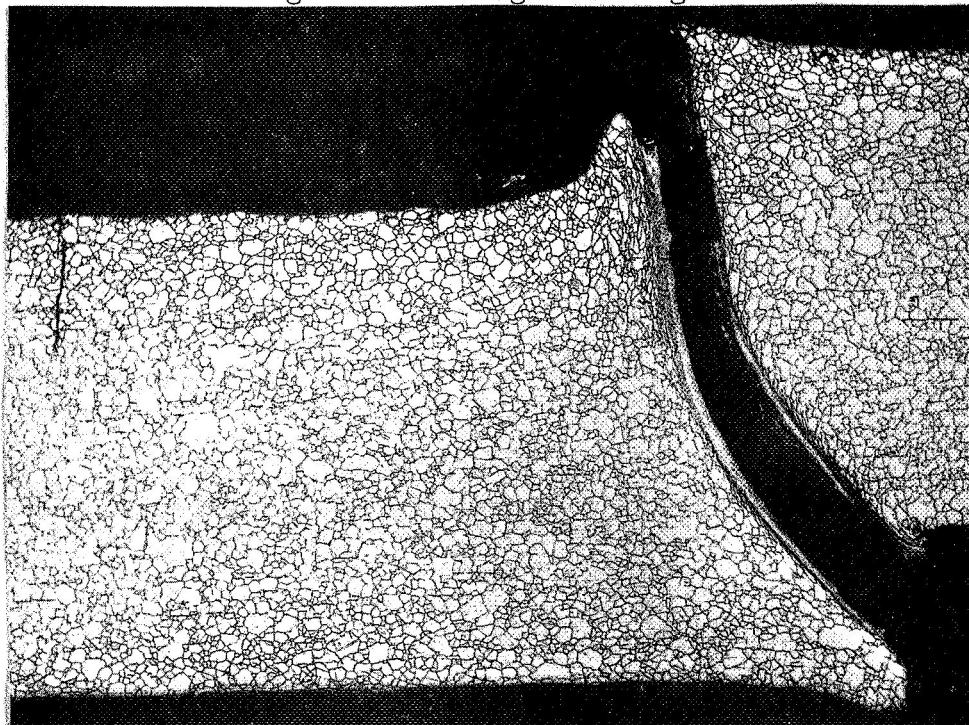
A photomicrograph of the failed section of the tube is shown in Appendix A. A metallographic comparison of the failed 321SS with an unfailed tube indicated a normal structure except at the fracture where the structure was austenitic. The percentage of sigma phase present in the normal 321SS structure was less than one percent.

6. Hydrogen embrittlement combined with residual assembly stresses caused the failure at the Ta-10w swirl wire.
7. The static NaK tube failure was caused by excessive stress, inherent in the boiler design, occurring cyclically during system startup and shutdown.

Figure 3 - Cross section through failure area of 321SS static NaK tube.

1. Design modifications should be made to reduce the stress level in the static NaK tube at the Hg inlet and in other areas if stress analysis indicates failure is probable.
